Verification highlights

The importance of maintenance: inspecting hydroacoustic station HA01 at Cape Leeuwin, Australia

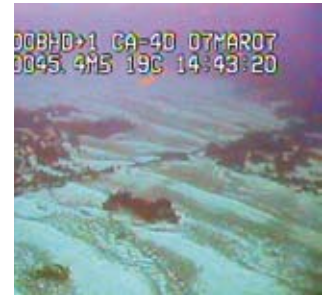
LIVE VIDEO RECORDINGS SHOWING PARTIALLY OVERGROWN CABLE AT HYDROACOUSTIC STATION HA01, CAPE LEEUWIN, AUSTRALIA.

Altogether, the inspection team recorded nearly 20 hours of video material, spending roughly ten hours per day on the boat tracking the cable and analyzing the video recordings. No additional kinks or loops were found. Thus, the near-shore section of the cable of HA01 has remained stable since 2003. If any irregularity or damage, which could have led to a future cable break, had been identified during the inspection, an early repair would have minimized interruption to continuous data flow and would have saved the CTBTO considerable costs of a later major repair. ■

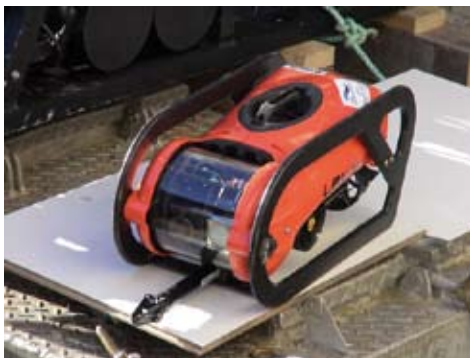
REMOTELY OPERATED UNDERWATER ROBOT

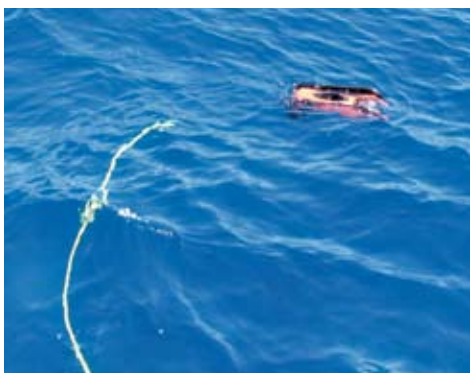
UNDERWATER ROBOT WITH 'UMBILICAL' CABLE, READY FOR INSPECTION DIVE
